**ANDREW MAHONEY** Statement

**CHRISTOPHER POLASHENSKI Statement**

HOWARD REESE Statement

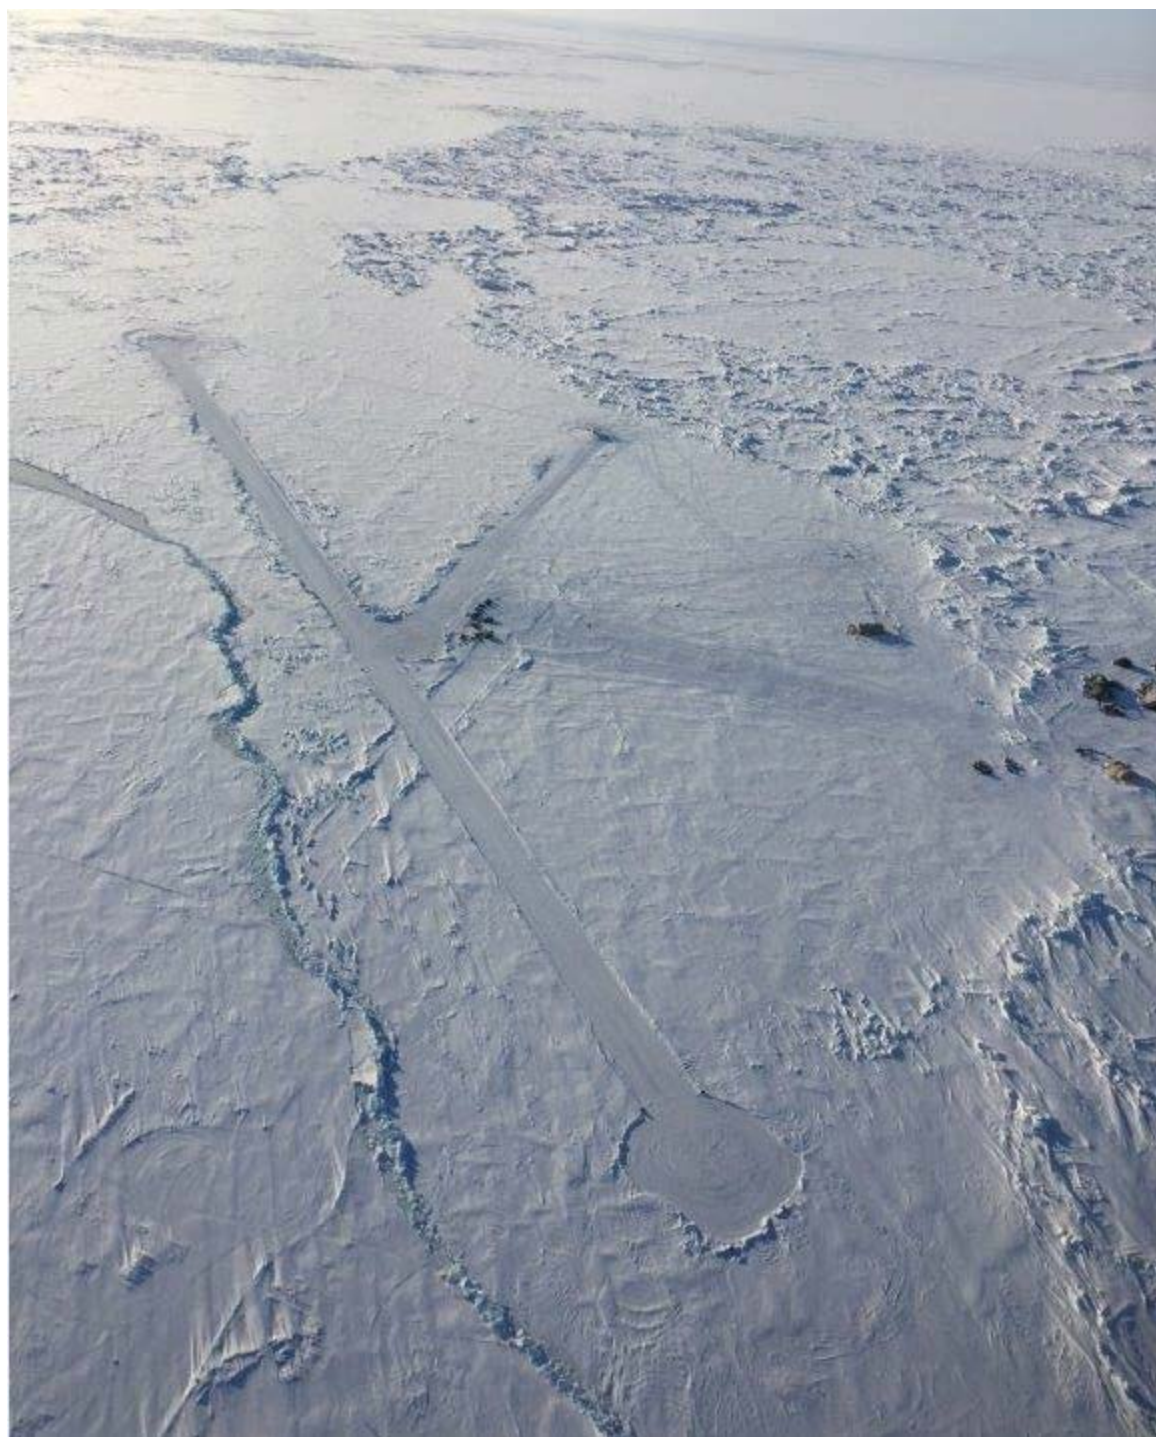
HOWARD had inquired of a Casa pilot as to how wide the runway needed to be. The Casa pilot had requested 60' wide, and so Howard made the runway between 60 and 70 feet wide. The longest runway, which ran in a generally NorthEast / SouthWest direction, was approximately 2400' long. The shorter runway, which intersects the longer one in about the middle, was about 1500' long. (See attached photo of runway area)

There were snow berms about two (2) feet tall along the edge of the runway, with a snow berm about four (4) at the intersection area. The area where the accident occurred was at the intersection area. The snow berm in that section was about four feet tall, and about 10 to 15' wide. This was the section that TRAVIS, the victim, had been behind when taking photos.
